35 Eccles Court,  
STIRLING,  
FK7 9AT

# Home Report

# Single Survey

<b>Property Address</b>	35 Eccles Court, STIRLING, FK7 9AT
<b>Reference</b>	1552386
<b>Customer Name</b>	Martin Hall
<b>Date of Inspection</b>	30th April 2026
<b>Surveyor's name, qualifications and office</b>	Thomas Fergusson MRICS DM Hall LLP Chartered Surveyors Suite 2C 1 Pitt Terrace Stirling FK8 2EZ  Tel: 01786 475785  email: <a href="mailto:stirlingresidential@dmhall.co.uk">stirlingresidential@dmhall.co.uk</a>
<b>Prepared By</b>	DM Hall LLP

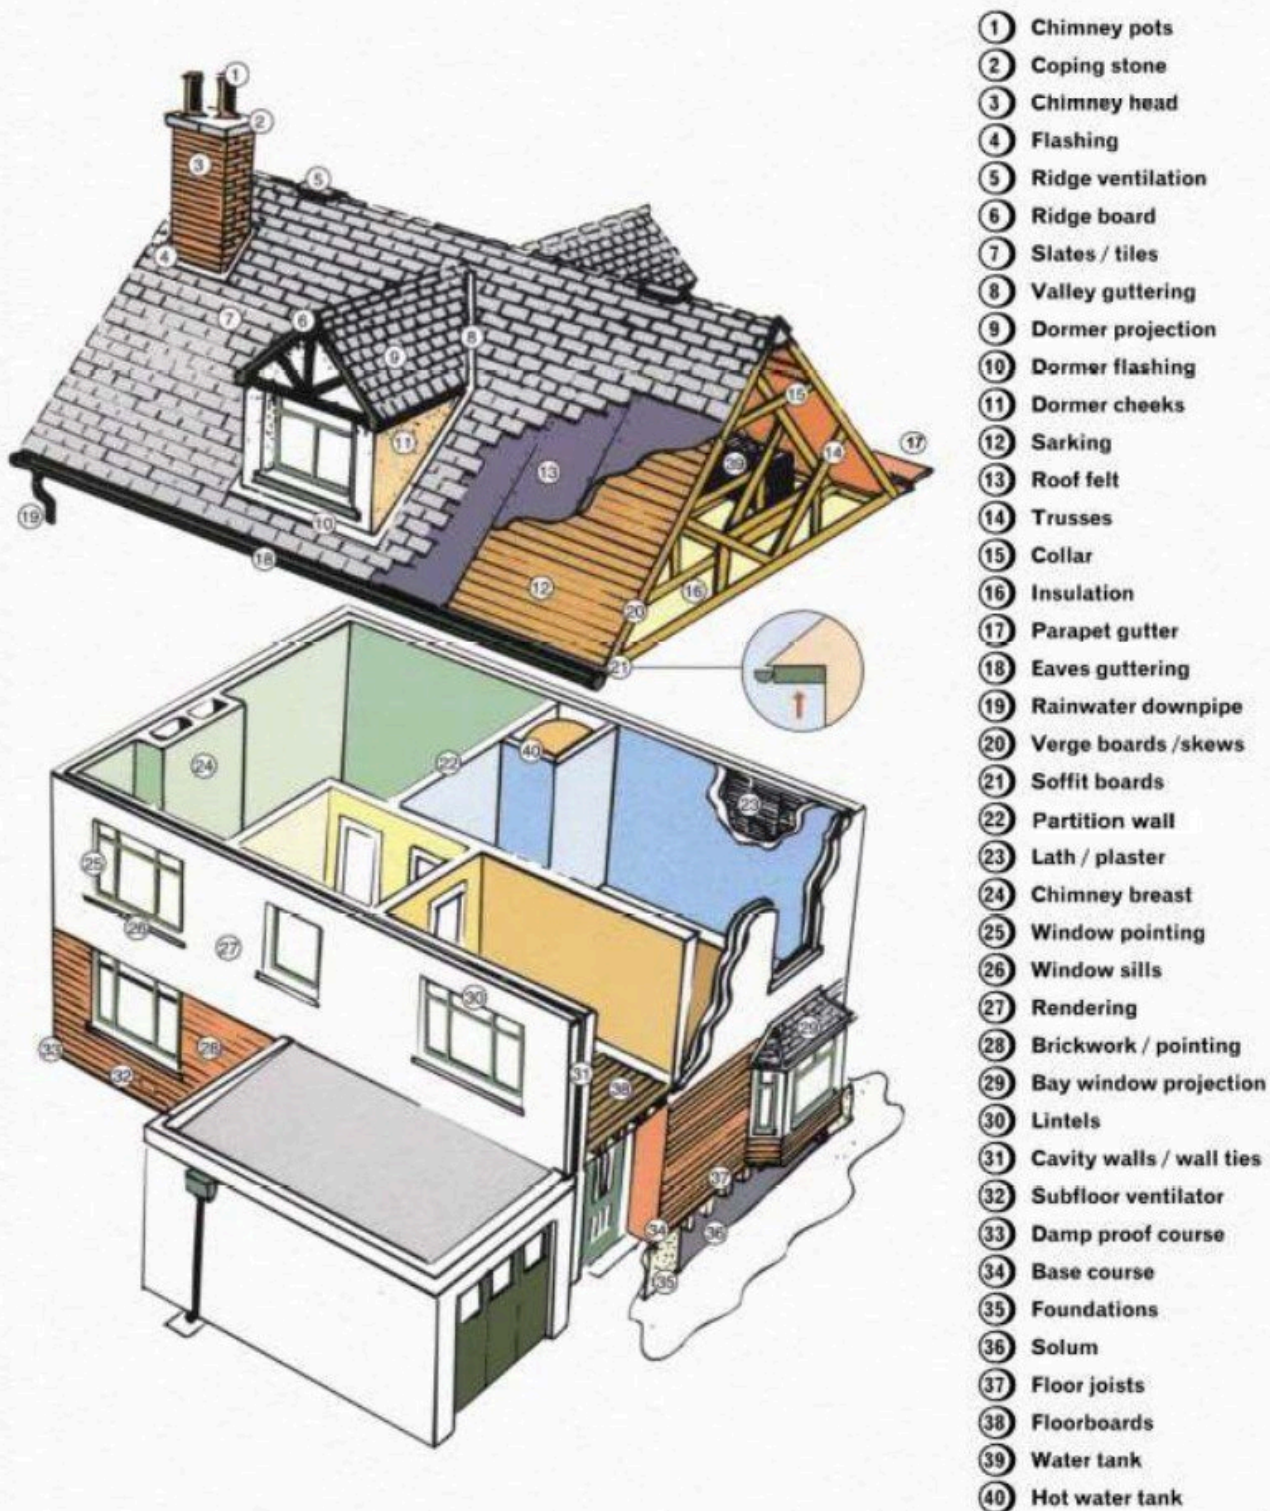
## Sectional Diagram showing elements of a typical house

Reference may be made in this report to some or all of the above component parts of the property. This diagram may assist you in locating and understanding these items.

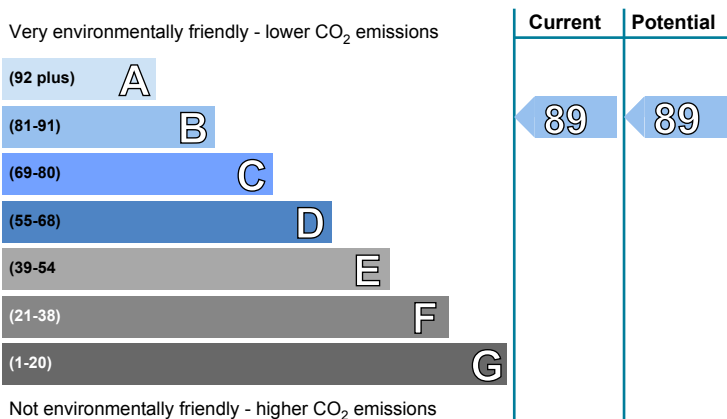
## Environmental Impact (CO<sub>2</sub>) Rating

This graph shows the effect of your home on the environment in terms of carbon dioxide (CO<sub>2</sub>) emissions. The higher the rating, the less impact it has on the environment.
